# STRUCTURAL CONDITION REPORT

MILESTONE INSPECTION HB5D - **PHASE 1**

## INTERCOASTAL CONDOMINIUMS

**INTERCOASTAL CONDOMINIUMS  
REPORT# 23-009.SCR.HB5D.PH1.001**

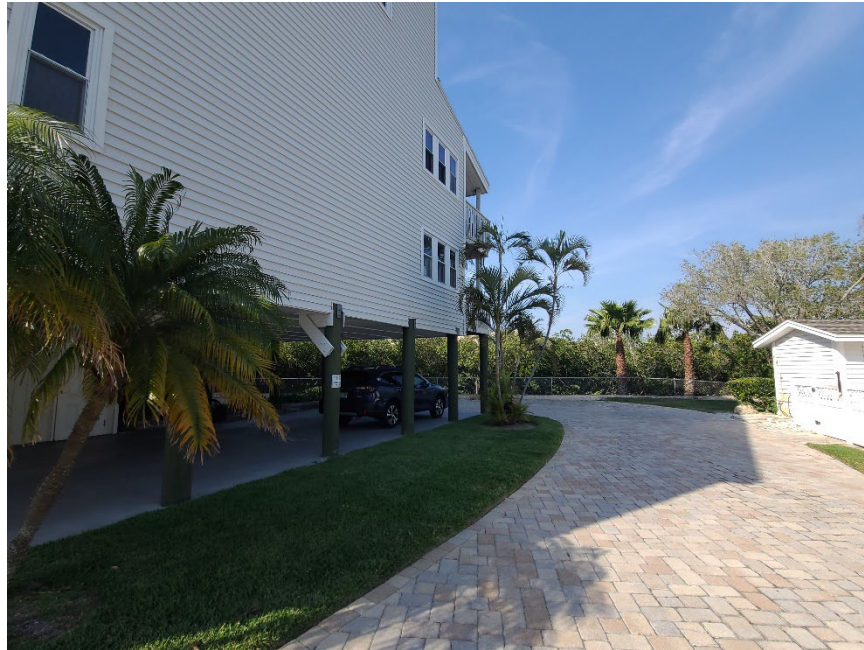
**EAST SIDE OF BUILDING + PILE SUPPORT**

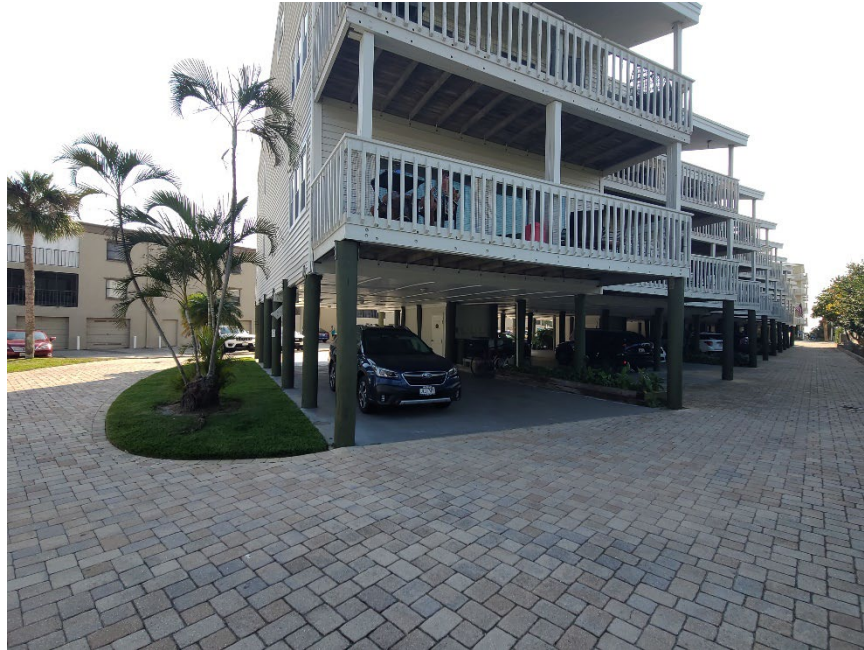
**NORTH SIDE OF PROPERTY + PILE SUPPORT**

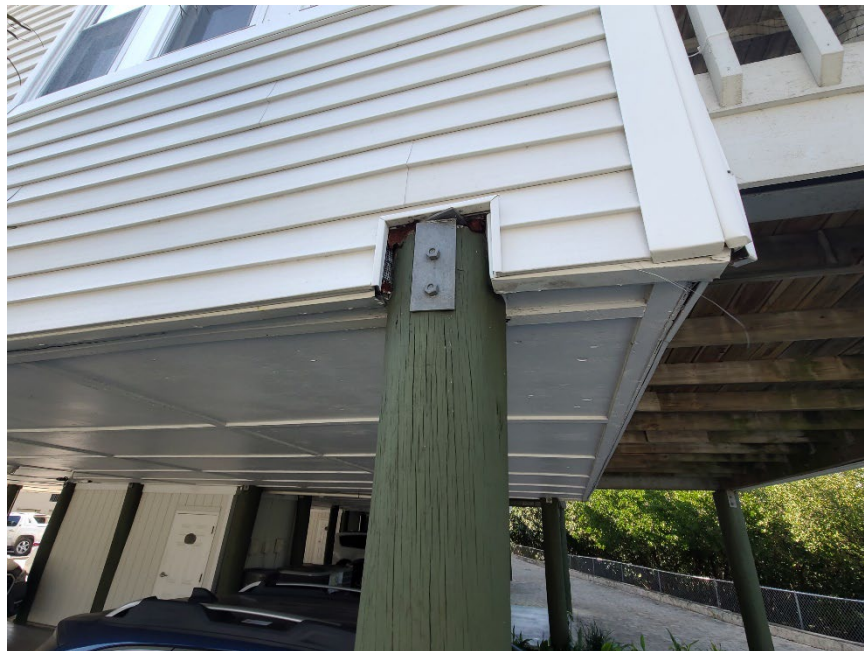
**TYPICAL PILE TOP CONNECTION**

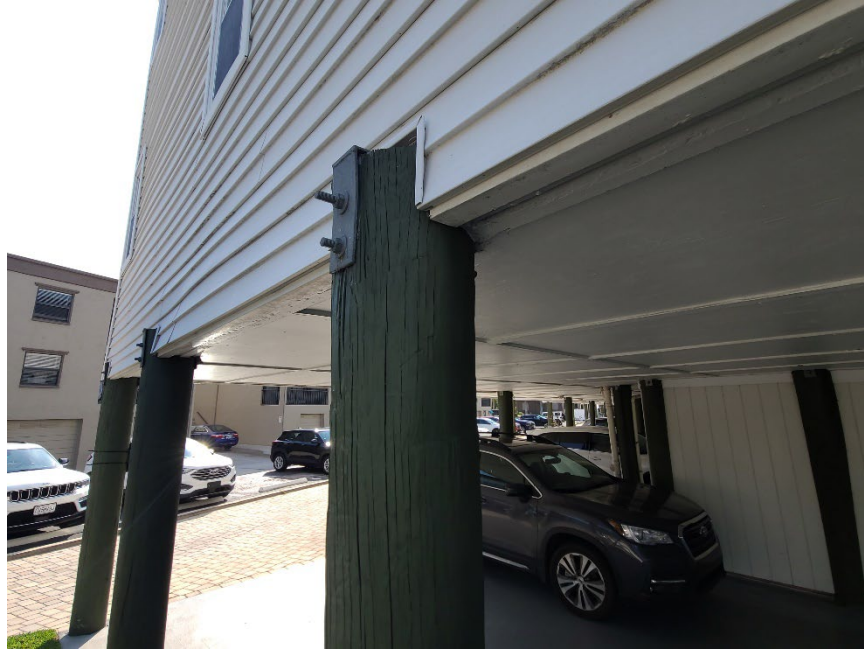
1. In general, the condition of the main vertical driven support piles is good. There is no visible damage from deterioration and no damage from impact or other trauma was noted. The piles observed in the field appeared to be plumb with no signs of warping or twisting noted.
2. The base of the piles at the asphalt do not show signs of moisture intrusion or rot and are in good condition.

SERIES OF PILES + TOP CONNECTIONS

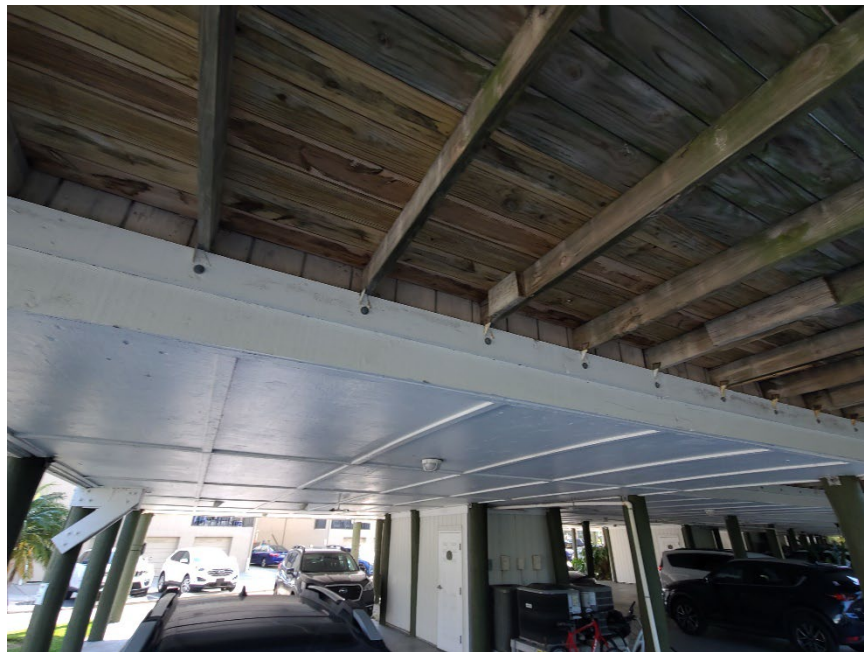
FLOOR JOIST CONNECTION AT PORCH

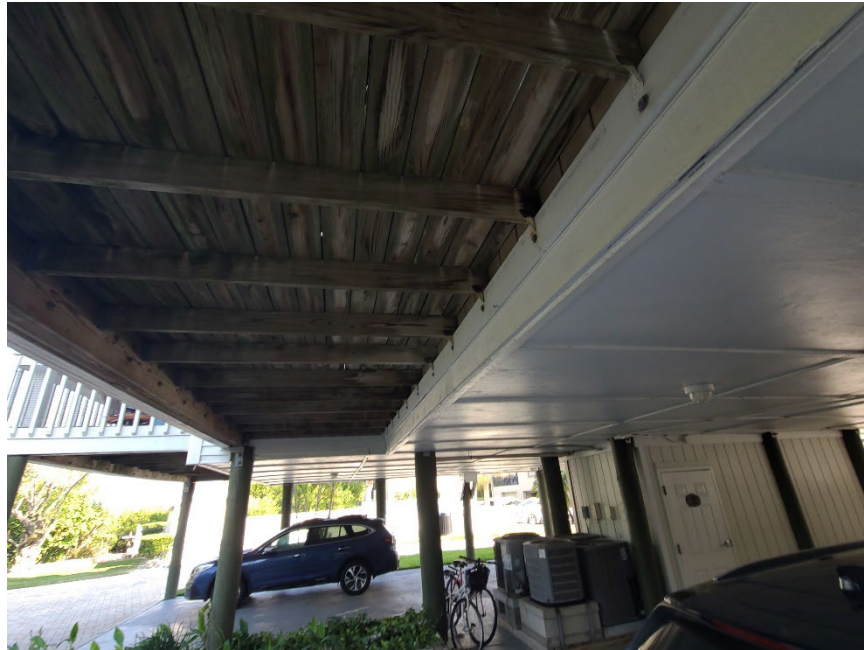
2. (MINOR deterioration noted) In general, the condition of the pre-manufactured clip angles and hangers was fair. Rust and minor deterioration due to exposure from airborne salts was observed in a significant number of the connections. Most clip angles and hangers observed appeared to be 16 gage or thinner metal with a galvanized coating that has been painted over in some locations. The base material has begun to rust and in several locations the connection will need to be replaced.

FLOOR JOIST CLIPS REQUIRING REPLACEMENT / MAINTENANCE

Connections where the base metal connection appears to be rusting and deteriorated should be replaced to restore the connection to the state as originally constructed.

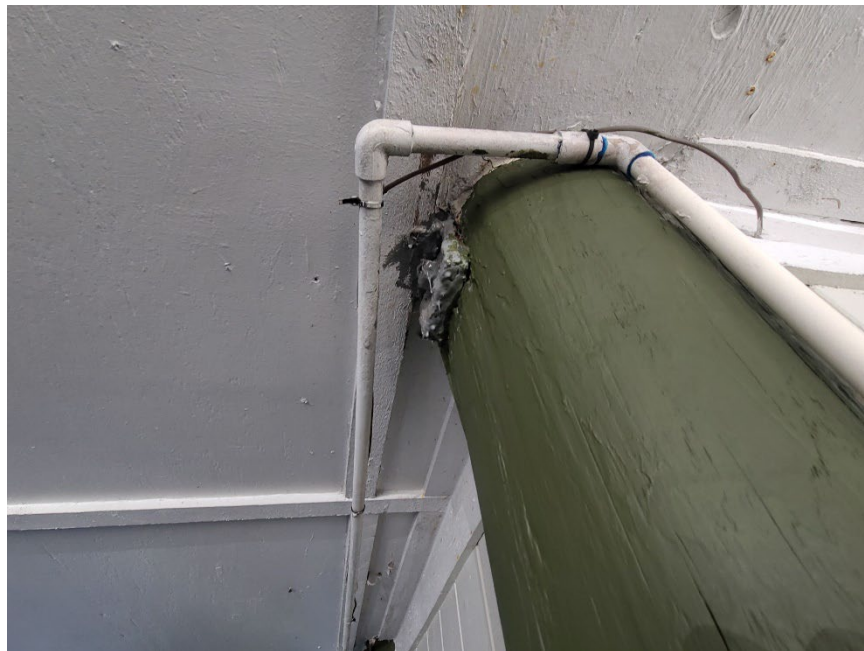
1. (MINOR deterioration noted) In general, the condition of the custom steel connections of the piles to the main carrying beams of the 2<sup>nd</sup> floor was satisfactory. Some locations require remedial repair to restore the connection back to its original condition. Wire brushing and repainting of the connections will be required in select locations. Fewer than 10 locations where connections required maintenance were observed.

CUSTOM CONNECTION CLIP REQUIRING MAINTENANCE

Connections where the base metal connection appears to be rusting and expanding shall be wire-brushed to bare white metal to remove all rust and scale. Where more than 20% of the base metal has been removed after wire-brushing, a new steel plate or clip angle shall be installed to match what existed previously.

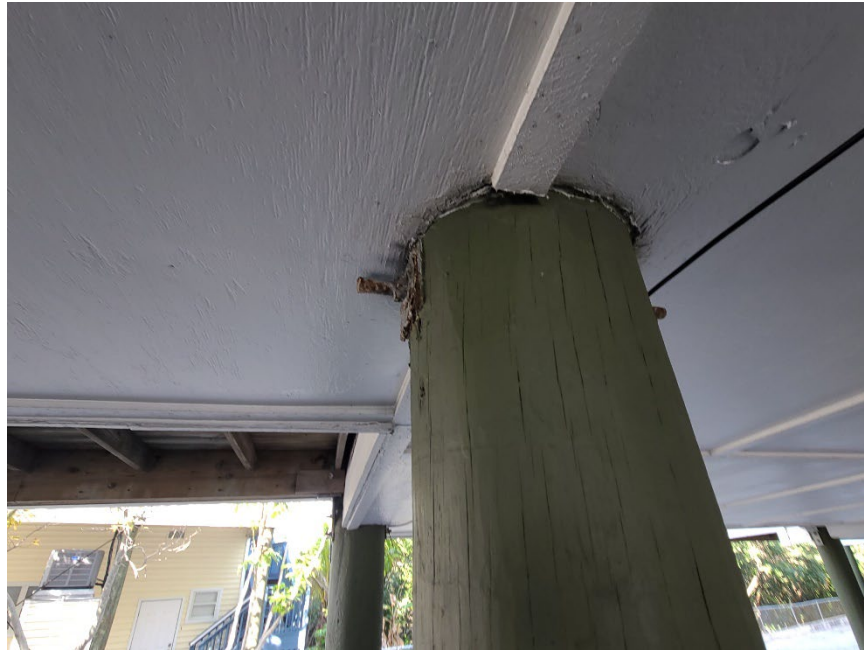
CUSTOM CONNECTION CLIP REQUIRING MAINTENANCE

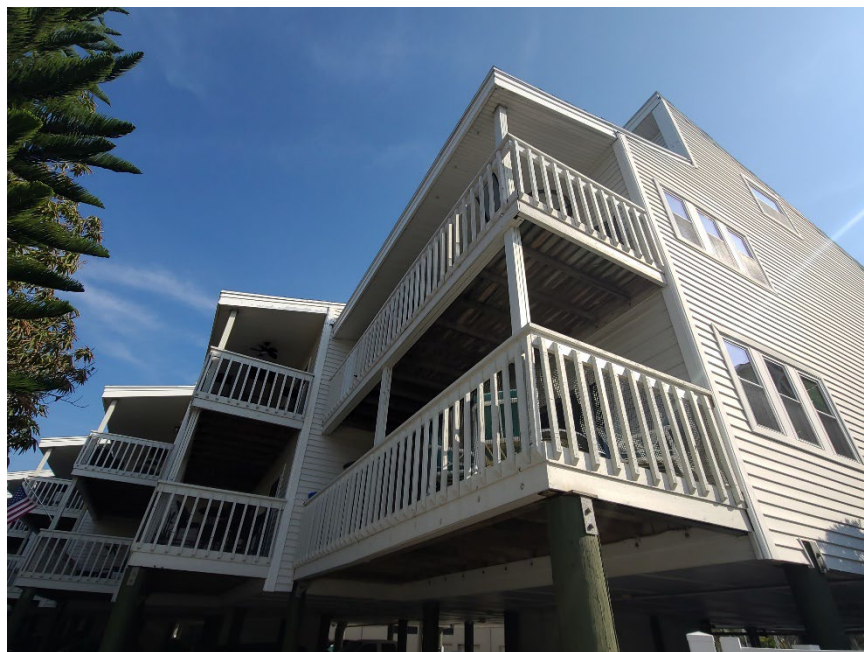
1. (MINOR deterioration noted) In general, the condition of the pre-manufactured clip angles and hangers at the exposed BALCONY framing was fair. Rust and minor deterioration due to exposure from airborne salts was observed in a significant number of the connections. Most clip angles and hangers observed appeared to be 16 gage or thinner metal with a galvanized coating that has been painted over in some locations. The base material has begun to rust and in several locations the connection will need to be replaced.

2<sup>ND</sup> + 3<sup>RD</sup> FLOOR PORCH FRAMING

Connections where the base metal connection appears to be rusting and deteriorated should be replaced to restore the connection to the state as originally constructed.

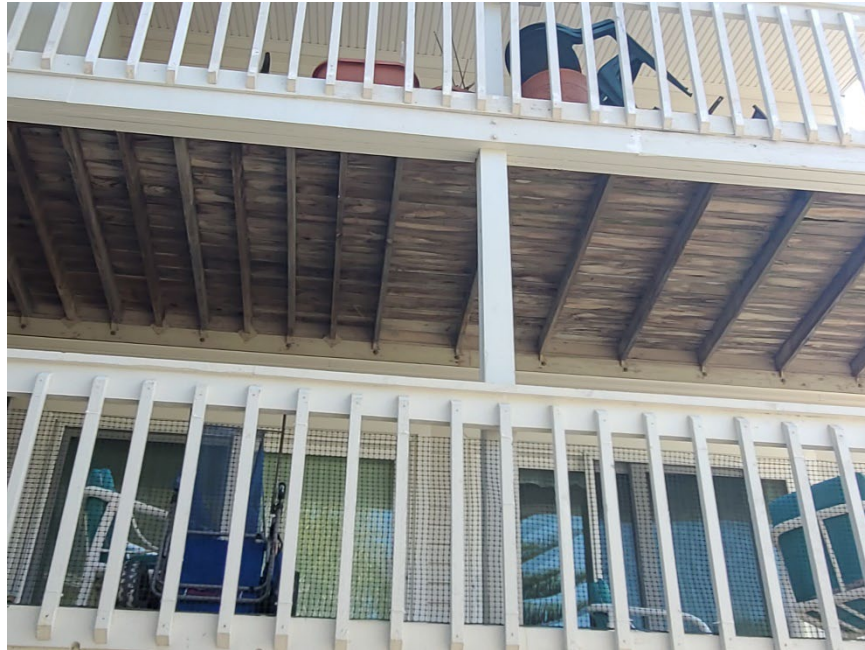
2. Framing members observed: All framing members exposed appeared to be in good condition. Rot, water staining, or other deterioration was not observed at the time of our site visit. (Framing members not exposed at the time of or site visit are excluded from this report)

3<sup>RD</sup> FLOOR BALCONY FRAMING (PREVIOUS REPAIRS MADE)
