Windstorm Mitigation Report (OIR-B1-1802)

The Intercoastal Condominium Association, Inc.

19727 Gulf Blvd. 20-Unit Risk

As of 01-16-2024 | FPAT File# MUD2321239

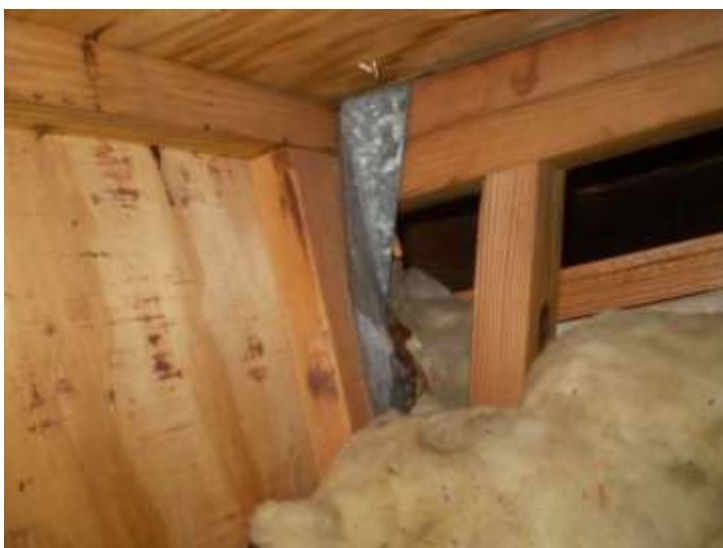
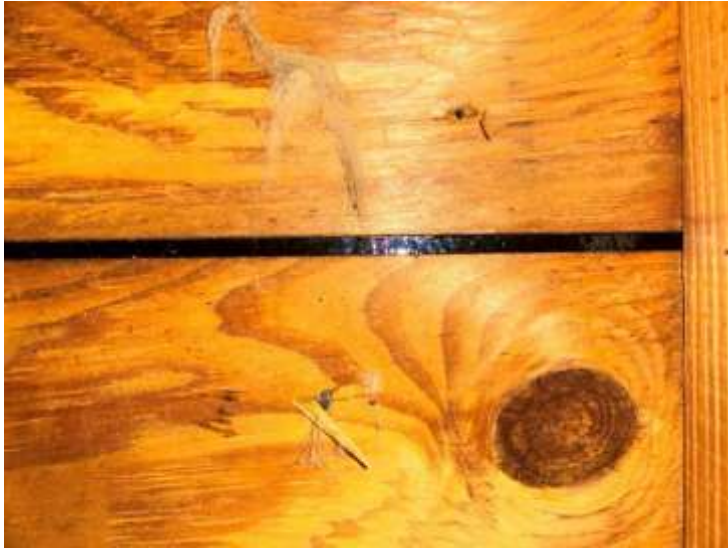
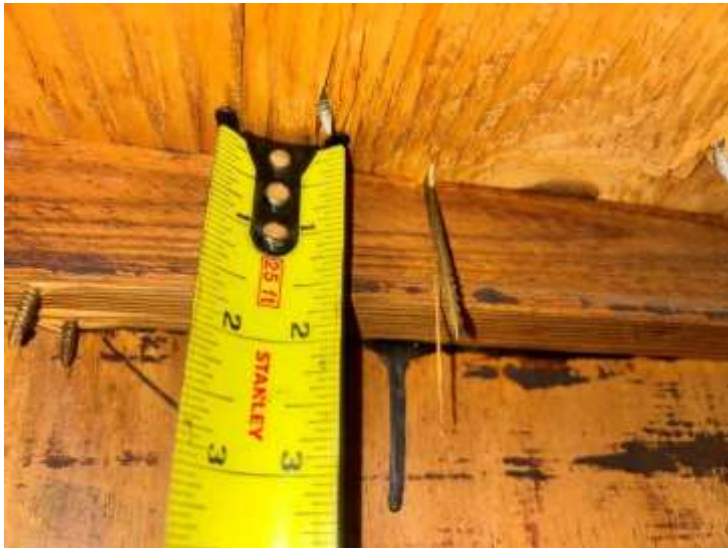
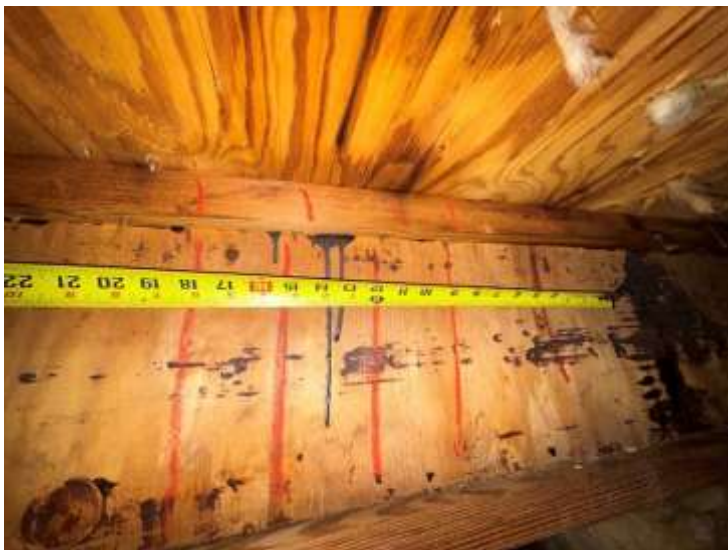
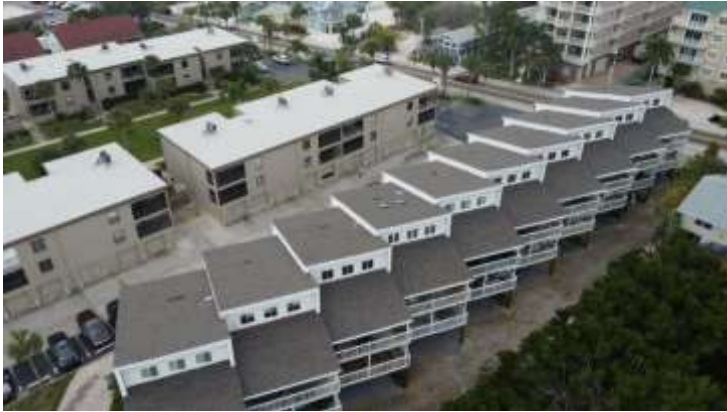
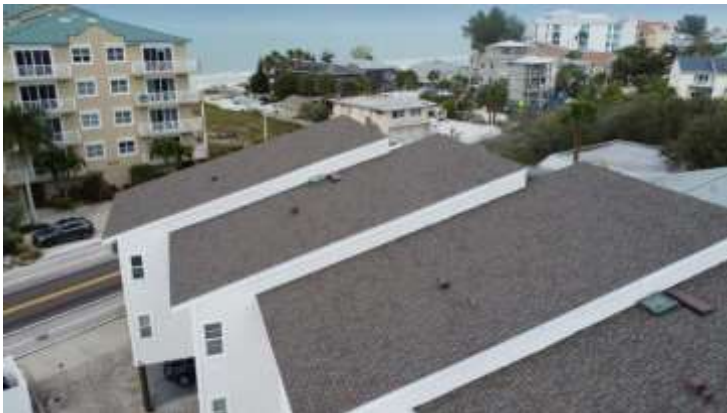
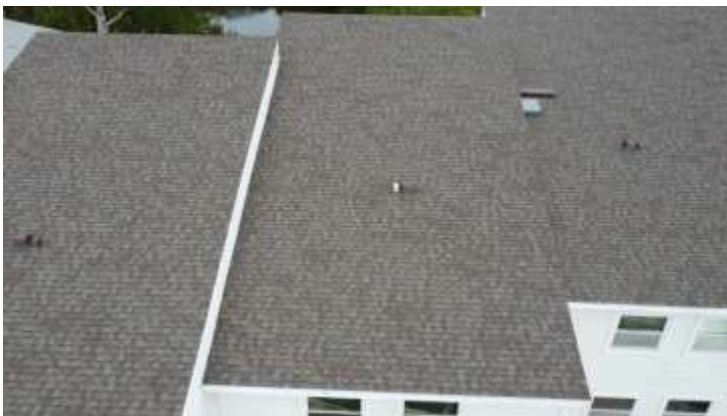
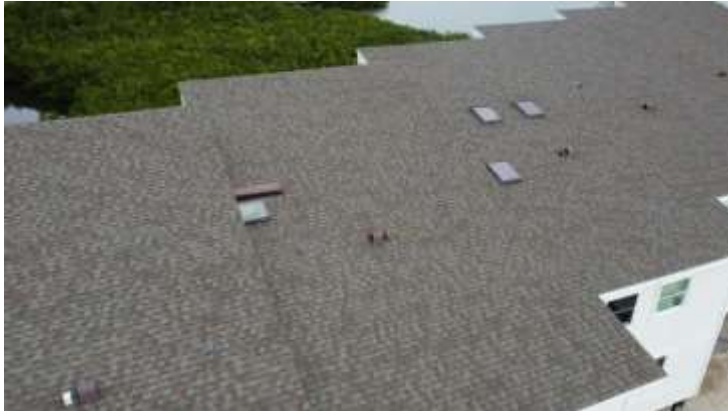
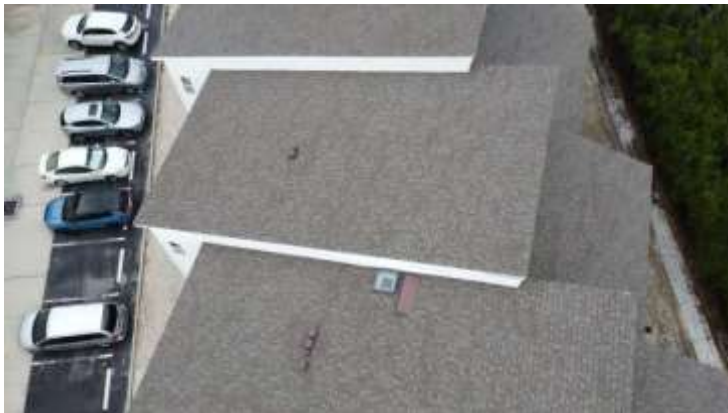
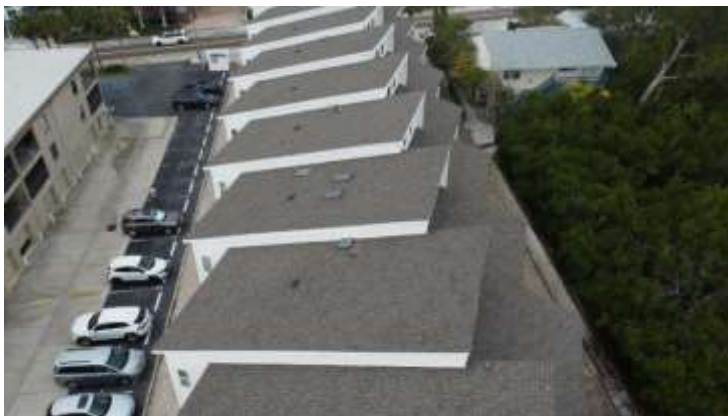
Roof Construction

- 3. Roof Deck Attachment:** **Level C**
Comments: Inspection verified 1/2" plywood roof deck attached with 8d nails at a minimum 6" on the edge & 6" in the field.

- 4. Roof to Wall Attachment:** **Clips**
Comments: Inspection verified metal straps fastened with a minimum of three nails.
- 5. Roof Geometry:** **Other Roof**
Comments: Inspection verified a gable roof shape.

- 6. SWR:** **Yes**
Comments: SWR was verified at time of inspection. The Secondary Water Resistance verified is a self-adhering peel and stick.
- 7. Opening Protection:** **Exterior Openings Cyclic Pressure & 9-lb Large Missile**
Comments: Inspection verified all windows and sliding glass doors are protected with laminated large missile impact rated glass.
