## Windstorm Mitigation Report (OIR-B1-1802)

The Intercoastal Condominium Association, Inc.

19727 Gulf Blvd. 20-Unit Risk

As of 01-16-2024 | FPAT File# MUD2321239

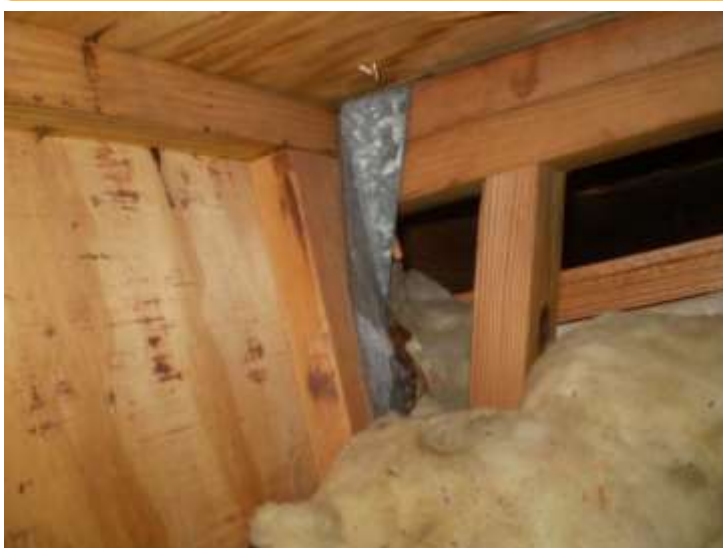
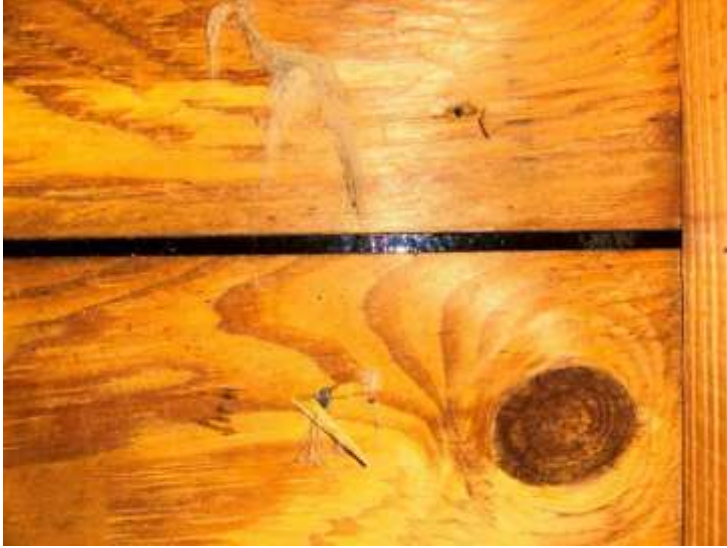
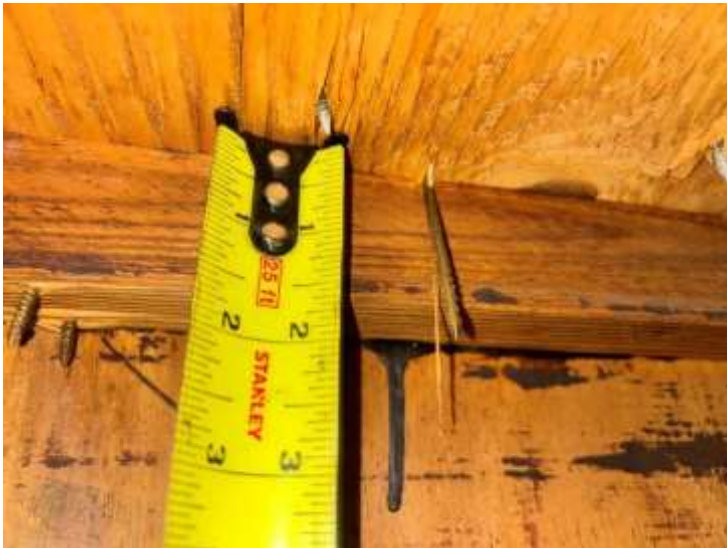
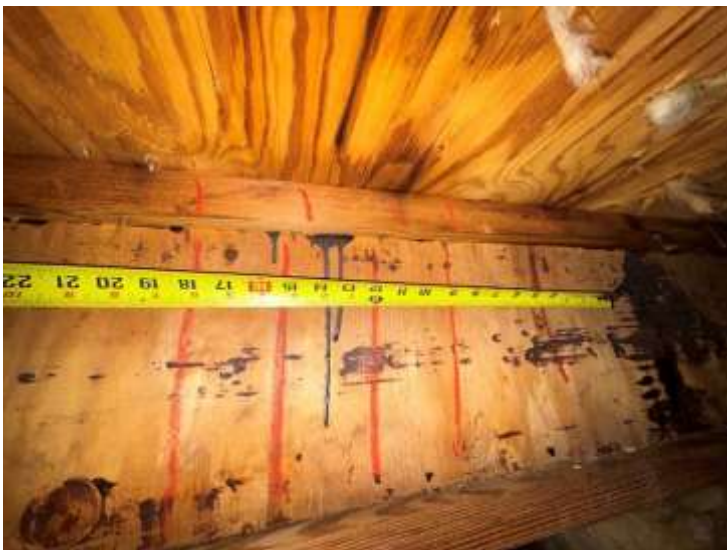
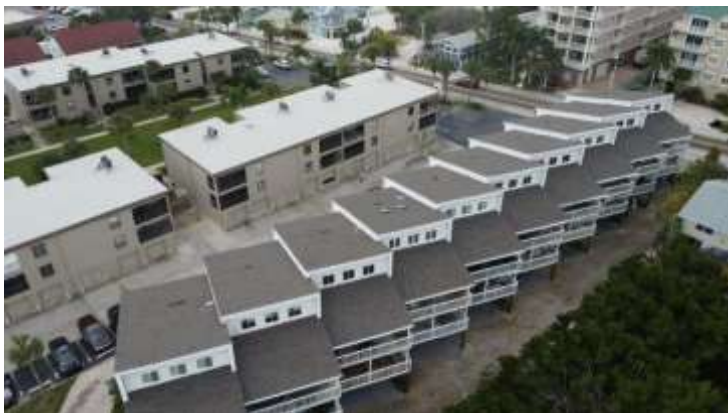
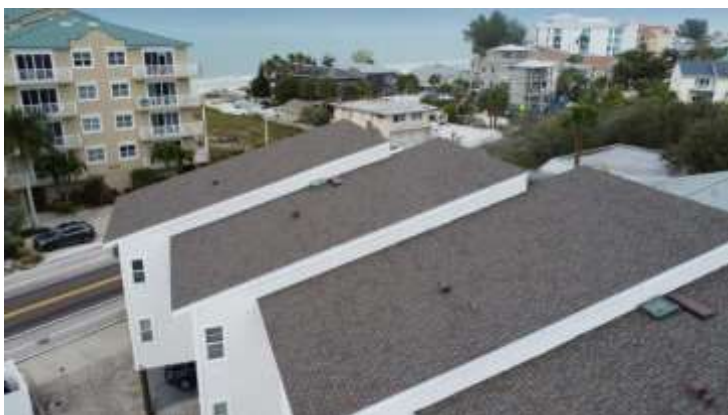
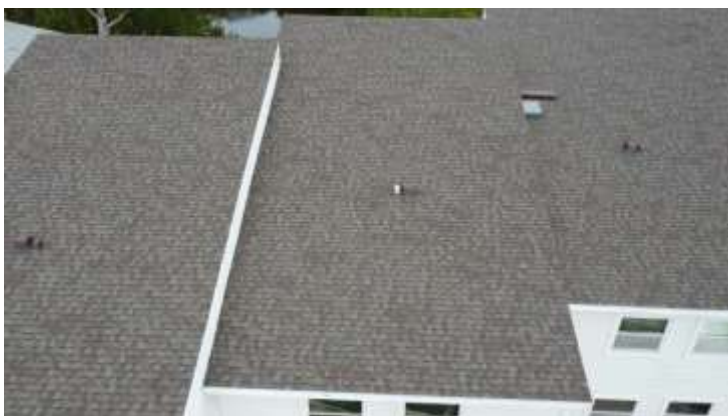
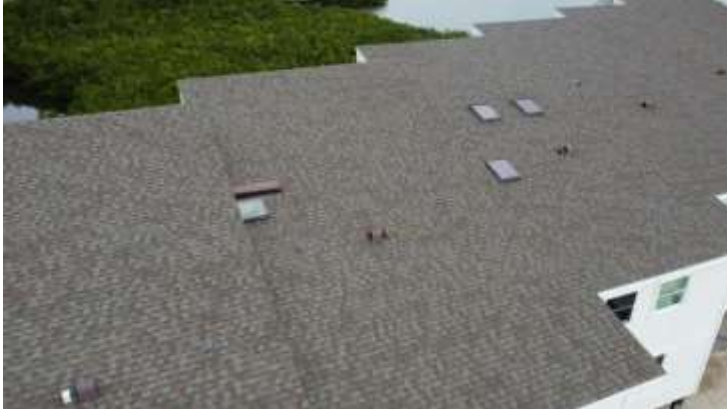
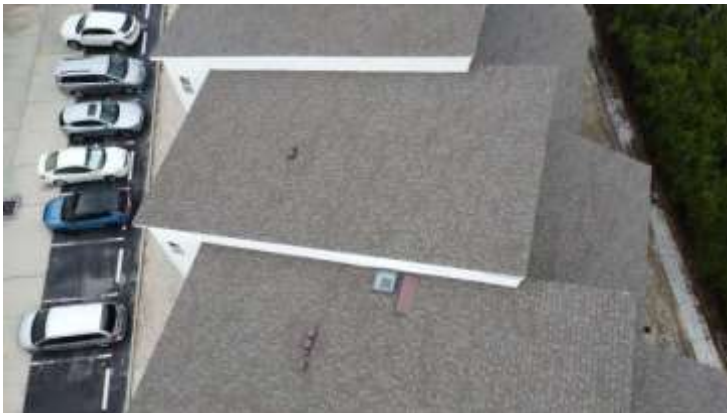
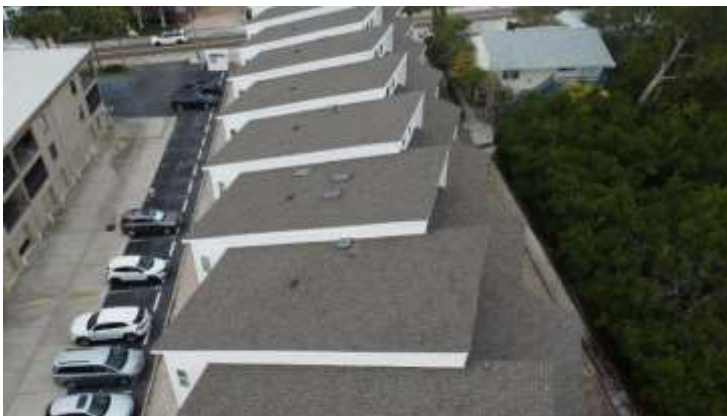
Roof Construction

| <b>3. Roof Deck Attachment:</b><br>Comments: | <b>Level C</b><br>Inspection verified 1/2" plywood roof deck attached with 8d nails at a minimum 6" on the edge & 6" in the field. |
| <b>4. Roof to Wall Attachment:</b><br>Comments: | <b>Clips</b><br>Inspection verified metal straps fastened with a minimum of three nails. |
| <b>5. Roof Geometry:</b><br>Comments: | <b>Other Roof</b><br>Inspection verified a gable roof shape. |
| <b>6. SWR:</b><br>Comments: | <b>Yes</b><br>SWR was verified at time of inspection. The Secondary Water Resistance verified is a self-adhering peel and stick. |

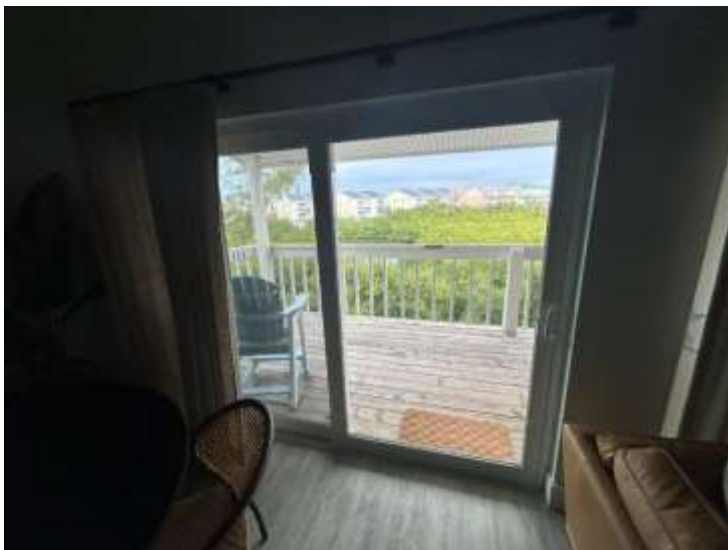
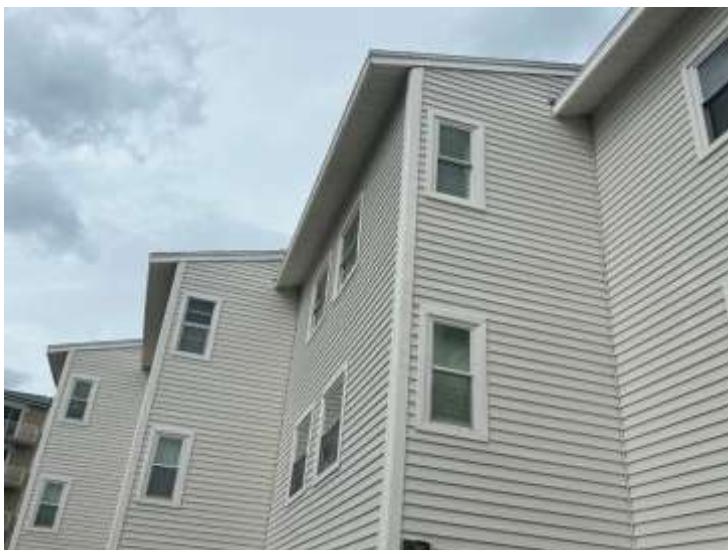
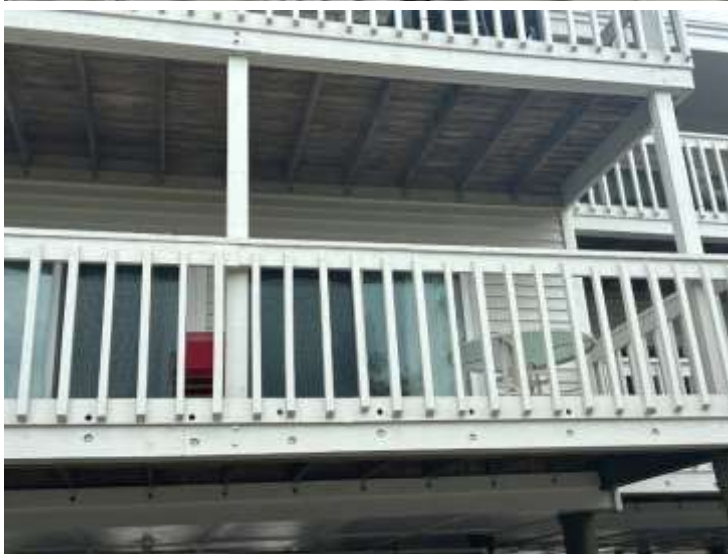
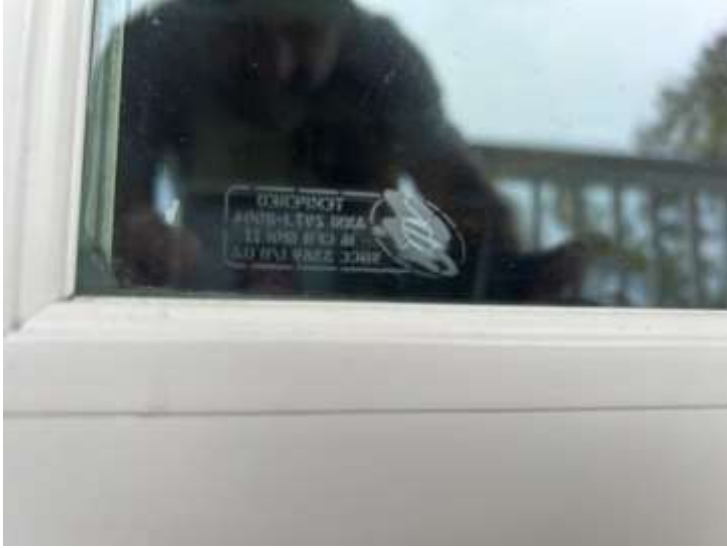
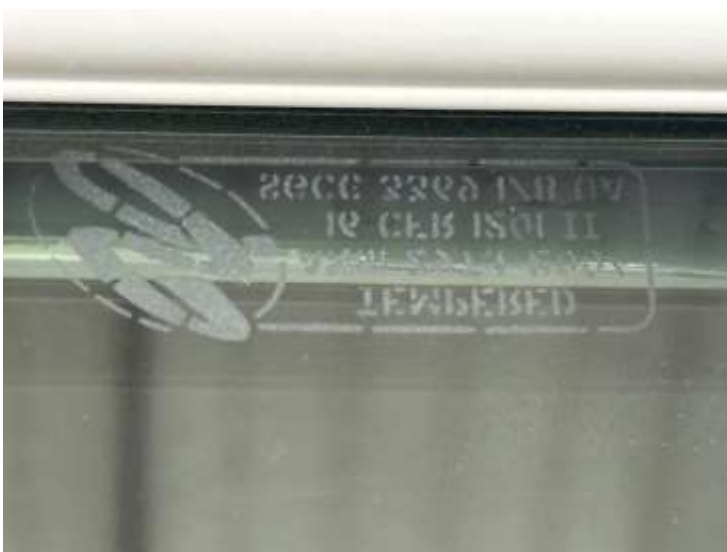
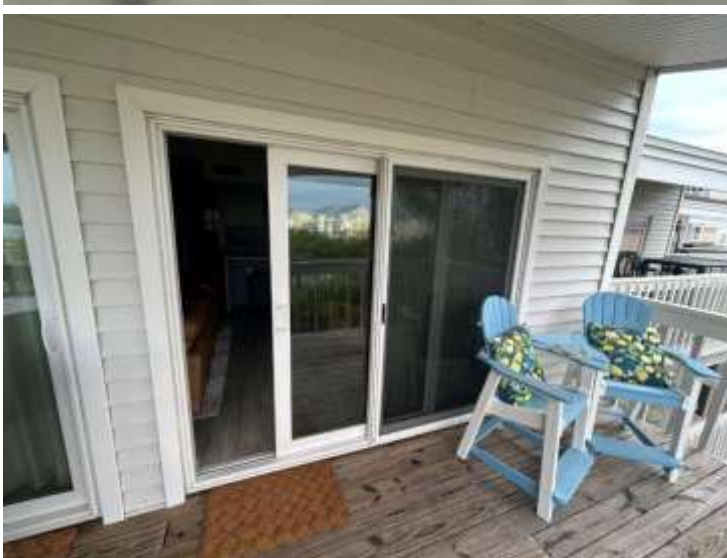
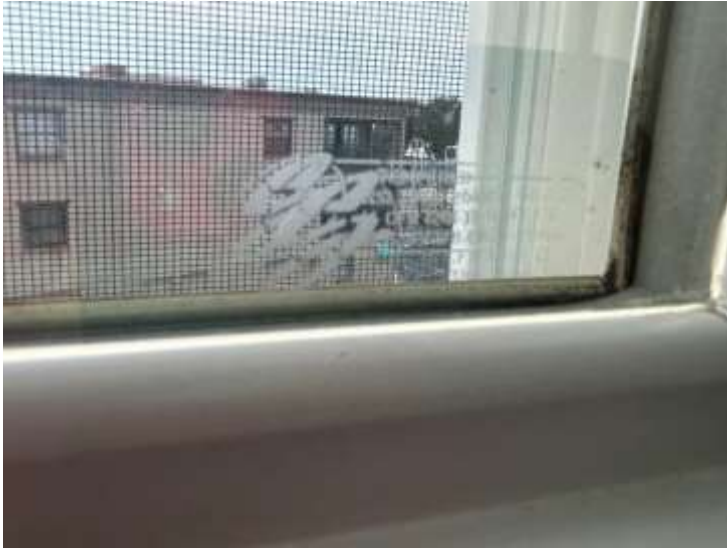
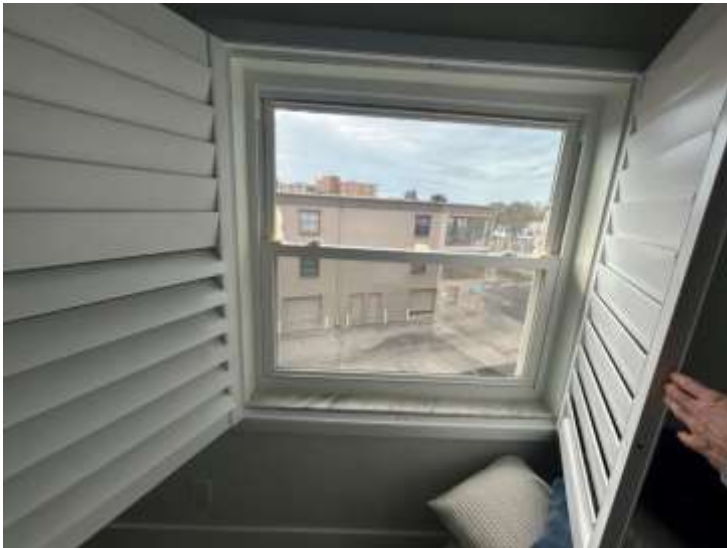
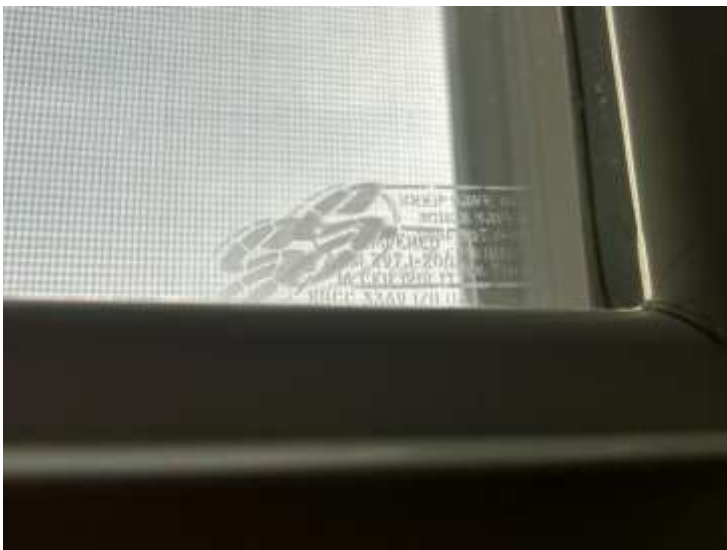
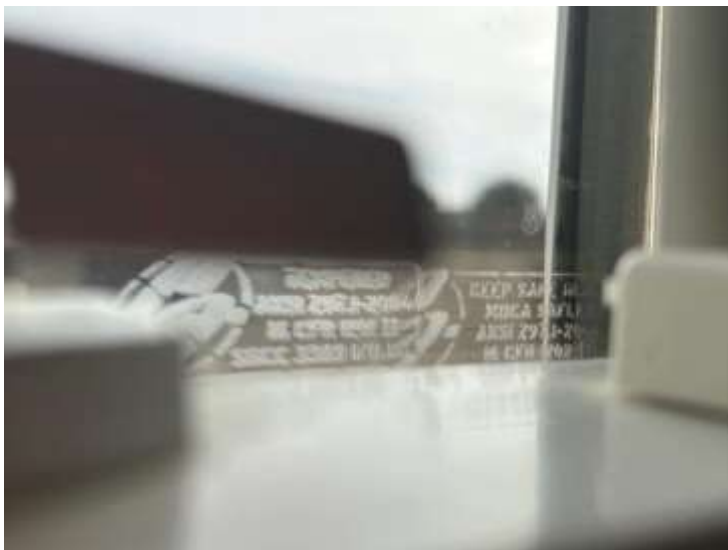
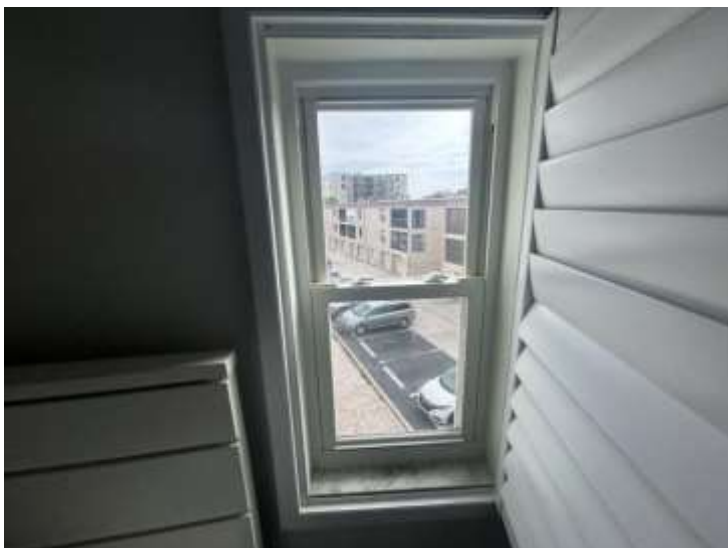
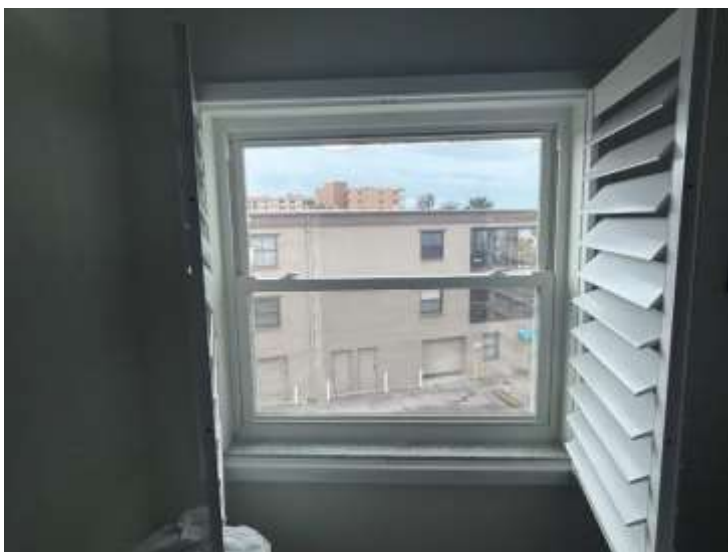
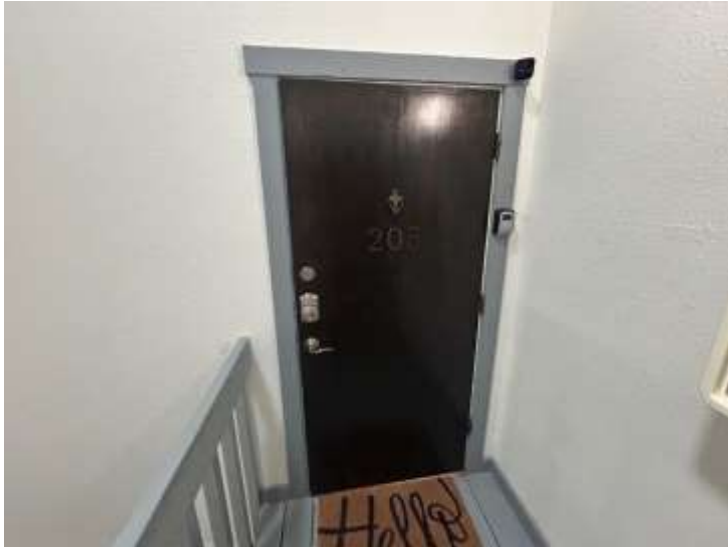
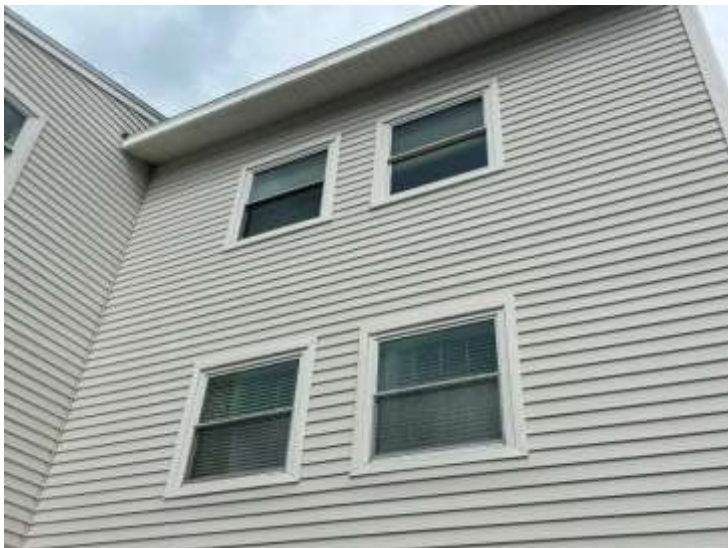
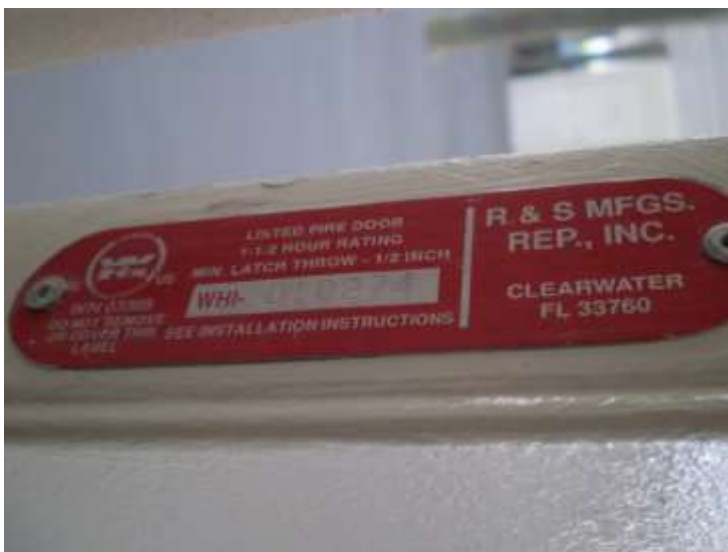
Opening Protection

| <b>7. Opening Protection:</b><br>Comments: | <b>Exterior Openings Cyclic Pressure &amp; 9-lb Large Missile</b><br>Inspection verified all windows and sliding glass doors are protected with laminated large missile impact rated glass. |
